**Aardvark Home Inspections**  
**2714 E 3<sup>rd</sup> Street**  
**Austin, Texas 78702**  
**512-228-9861**

## **PROPERTY INSPECTION REPORT**

**By:** Brian Evans TREC Lic# 9029 2006  
(Name and License Number of Inspector) (Date)

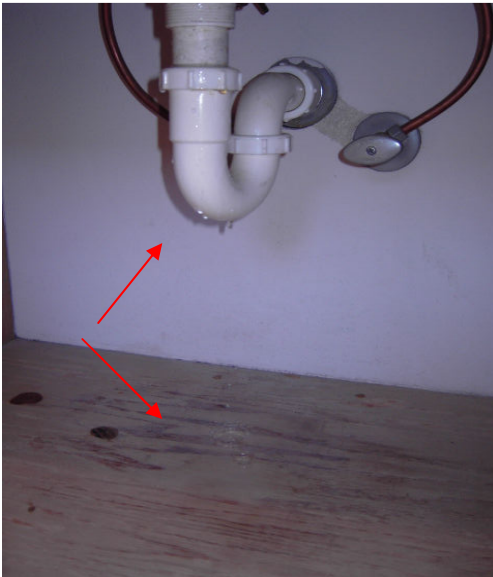
- Leaky hot faucet handle observed in master and half bath
- Leak under kitchen sink
- Leak under both sinks in double master sink. (see **photo below**).
- Inoperable bath drain observed in tub.
- Water stains noted in 2<sup>nd</sup> bath
- Moisture reading around shower pan indicates a water leak under the adjacent floor. *This item should be remedied and/or budgeted for.*(see **photo below**.)
- Crack in sink bowl in master bath.

Please note visible leaking water to the left.

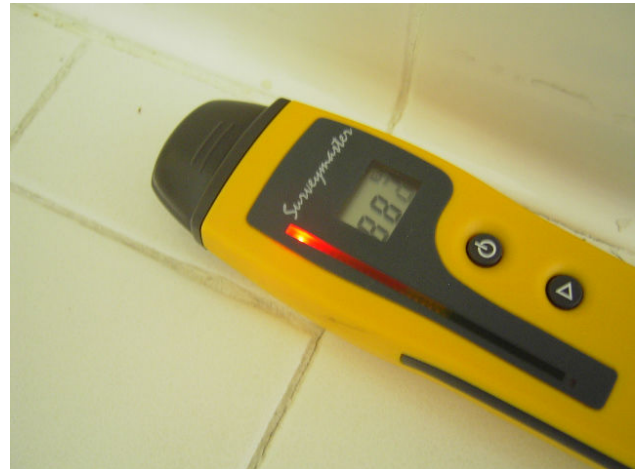
Please note high moisture reading in front of shower to the left. The meter does not read surface moisture. Rather it reads sub-surface moisture.

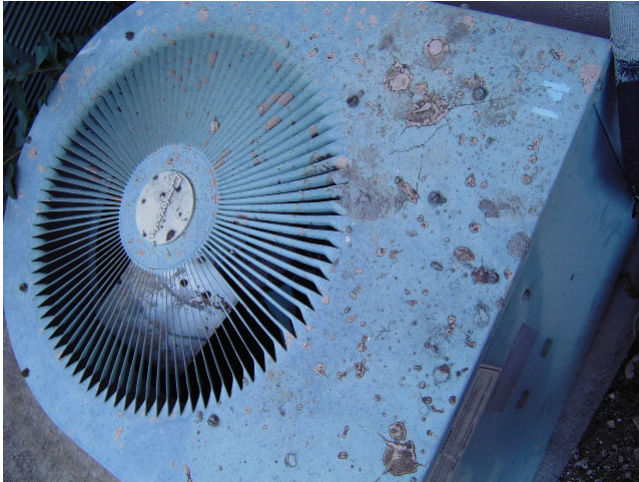
*The air conditioning system is very old. It will require a higher level of maintenance, and may be more prone to major component breakdown. Predicting the frequency or time frame for repairs on any mechanical device is virtually impossible. If the compressor fails, or if breakdowns become chronic, replacing the entire system may be more cost-effective than continuing to undertake repairs. The unit is so old that the model and serial number on the label have faded away. (Please see attached photo below).*

Please note photo of very old compressor unit. This unit is very near the end of its serviceable life.

- No secondary/ auxiliary condensate disposal method was found at the time of this inspection for either cooling unit.
- The temperature differential upstairs between the supply and return air is below average. This is indicative of a failing unit. Given the age of the compressor, it would be wise to budget for a new unit.

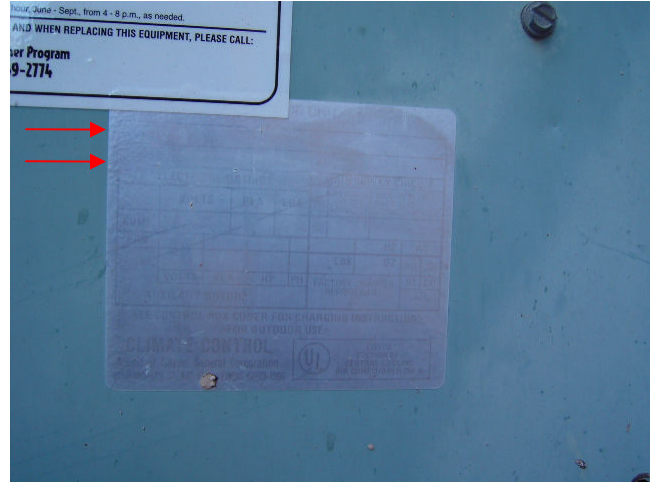
Please note photo of label. The model and serial numbers are faded beyond recognition.

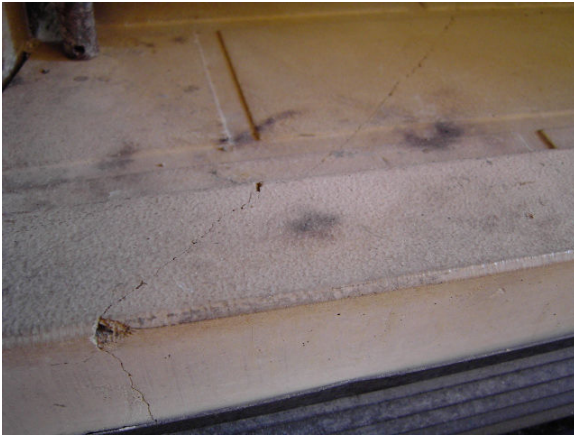
Please note cracked firebox above and approved hearth dimensions at right.

- **A crack in the firebox was observed. Please see attached photo.**
- No hearth extension was present in front of the fireplace. Charring has already occurred on the wood floor.

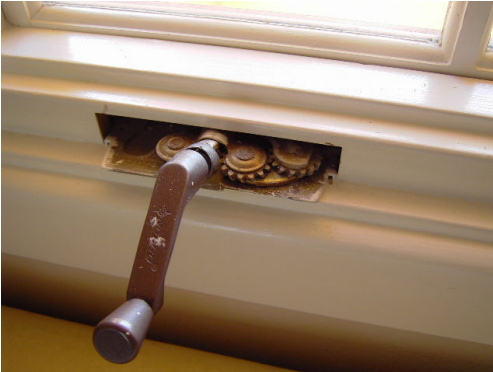
Photo of missing and inoperable hardware.

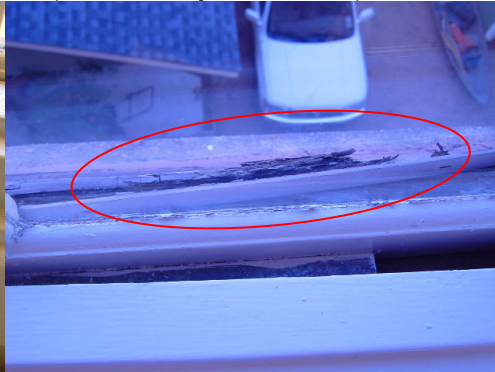
Photo of wood rot on outside of windows.

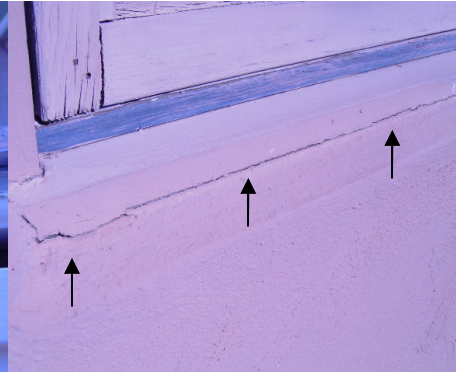
Photo of inadequate caulking and weatherproofing.

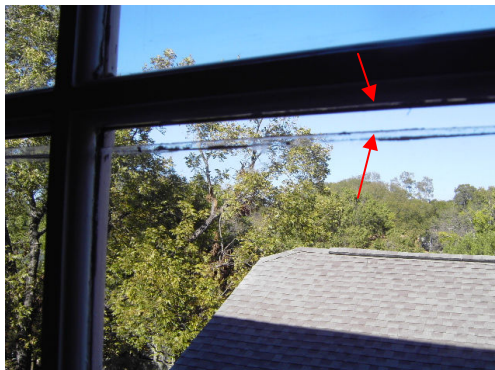
Photo of undersized window panes allowing air gap.

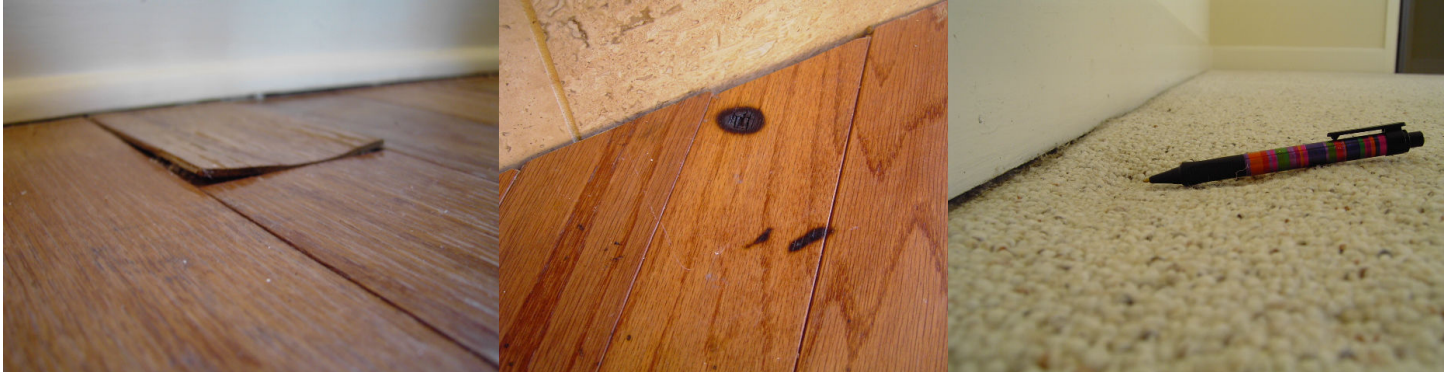
- Char marks observed on floors in front of fireplace. (Please see **photo below**).
- Low spot or possible hole observed in floor in master bedroom at exterior wall across from balcony door. (Please refer to **photo below**).

Peeling floor right of fireplace.

Char marks in floor.

Low soft spot in floor in master bedroom.

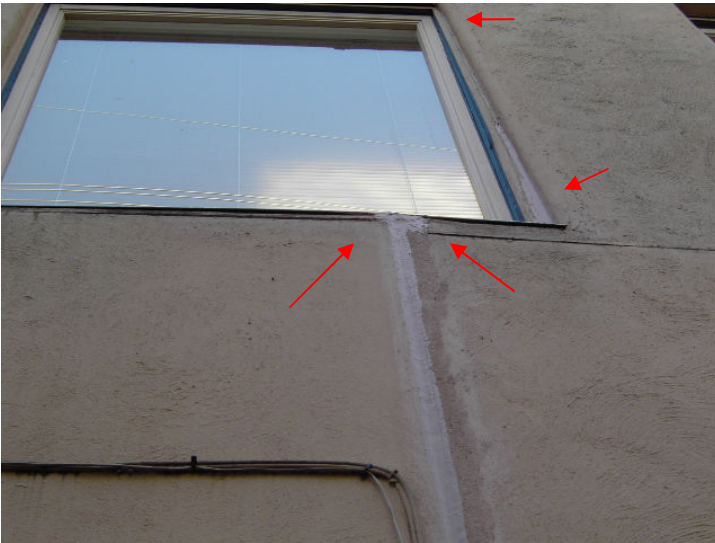
A 3-6 inch deflection noted in exterior wall. *This deflection seems to have more broad reaching implications. If recent foundation work has been done it seems to have taken a heavier toll on the exterior walls of unit #14. More so than most of the other units. No other wall units have as much deflection as the outside wall in of unit #14. Please refer to photo below. (picture below.)*

Though harder to see from this photo than in person this photo shows a vertical line that has been covered with plaster. The foundation problem seems to be most severe at this part of the units.

Please also note the out of square window frame relative to the window. There is a wider separation of frame to window from bottom to top. This is a common situation in the windows throughout the property.

After walking the exterior and the first floor level, it is the opinion of this inspector that the floors are unlevel and ***in need of a professional opinion from a structural engineer prior to closing***. Further evidence can be seen in the out of square window frames and bowing walls in various places throughout the property. The foundation is not performing as intended.
